ADMINISTRATIVE PROCEDURES

SUBJECT: Procedures for Handling Ballast Malfunctions
--

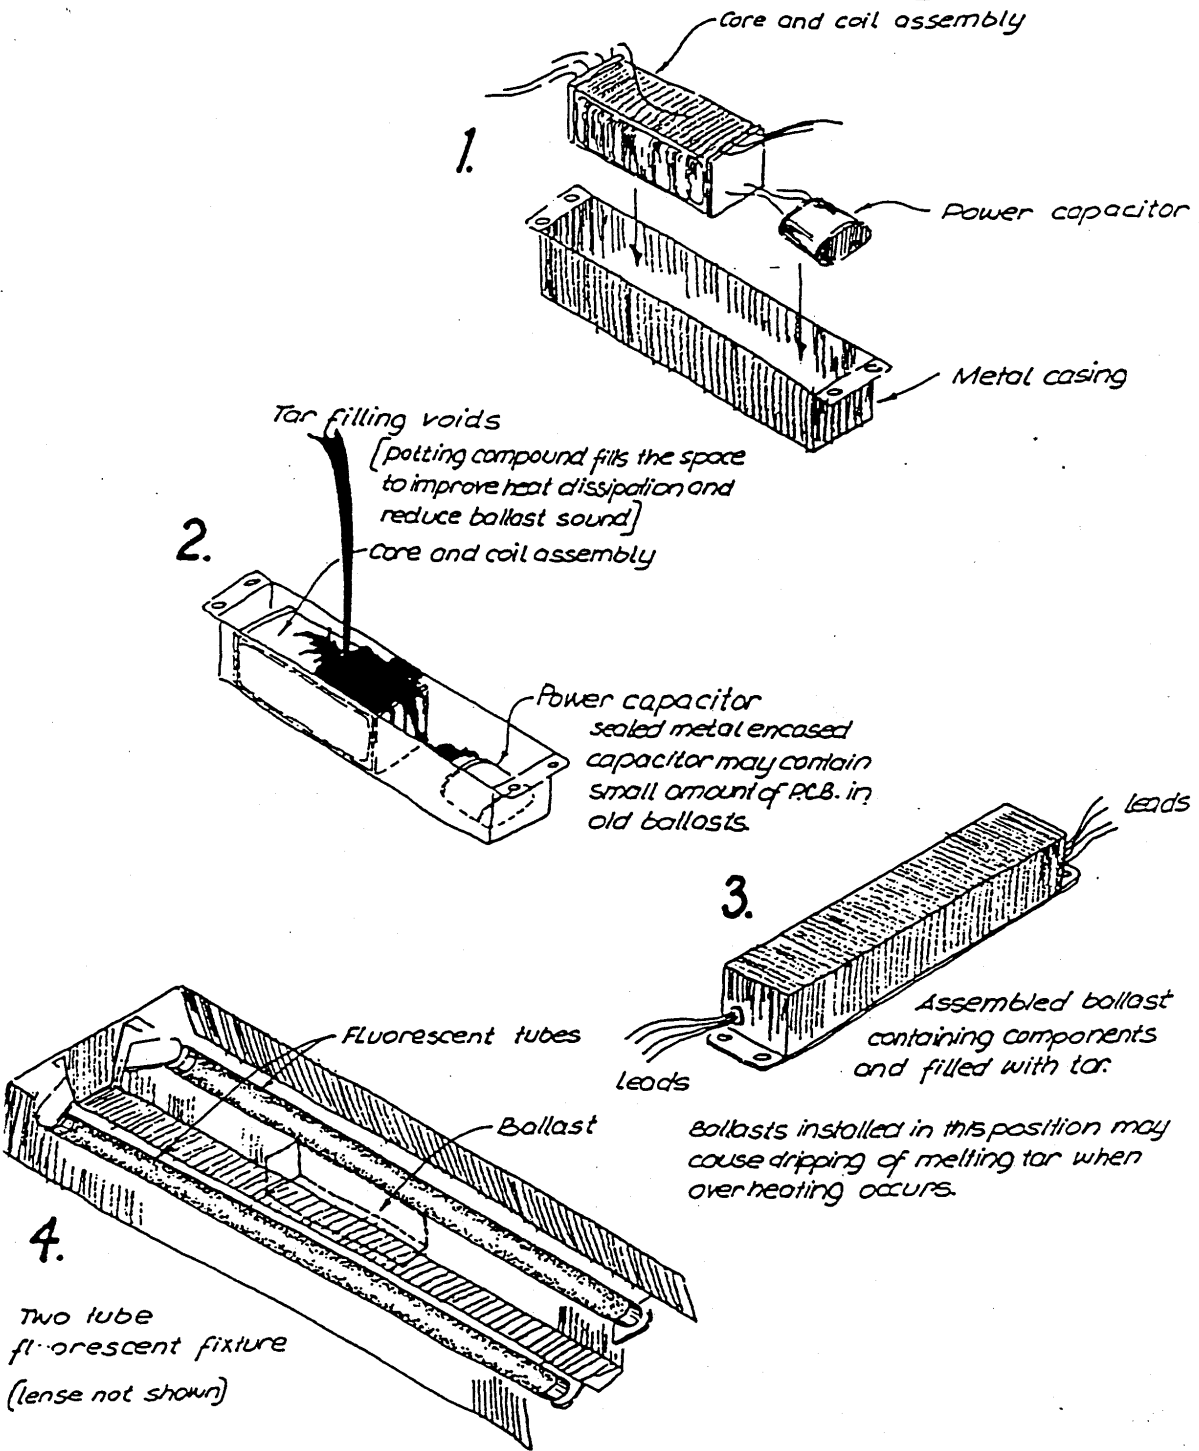
The Ballast

Please see the attached sketch, which shows the various parts of the light ballast and its position in a fluorescent light fixture. Note that the fluorescent tubes (bulbs) are not part of the ballast. A burnt out tube does not indicate overheating of the ballast.

1. The asphalt compound, which fills the ballast, may seep out of the joints of the casing and harden as it cools. This asphalt compound does not contain PCB material.
2. In very rare occasions, the capacitor can rupture resulting in oil (approximately 1.3 ounces) mixing with asphalt. In the highly improbable event of a rupture of the capacitor, no more than a fraction of the total oil, which may contain PCB material, could escape and mix with the asphalt. This oil will remain a liquid when cooled.
